IMPROVING ASSET MANAGEMENT PLANNING AT THE VILLAGE OF VALEMOUNT

SUMMARY OF FINDINGS & RECOMMENDATIONS

FINAL REPORT – MARCH 2020

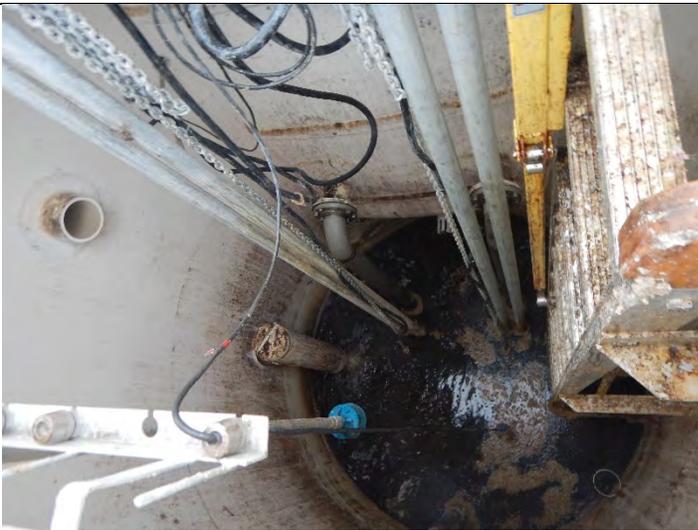
5th Avenue Lift Station

Photo shows the inside of the lift station wetwell, shows in good condition, and is the newest lift station in Valemout.

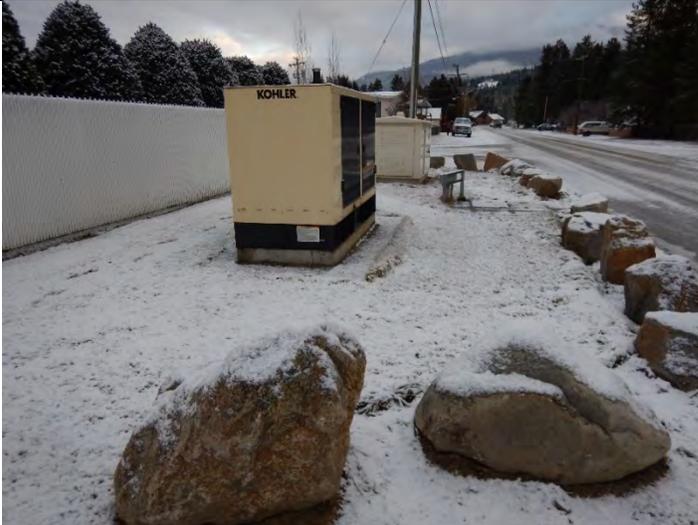
Photo of site plan at Ash Street Lift Station shows wet well, generator and kiosk.

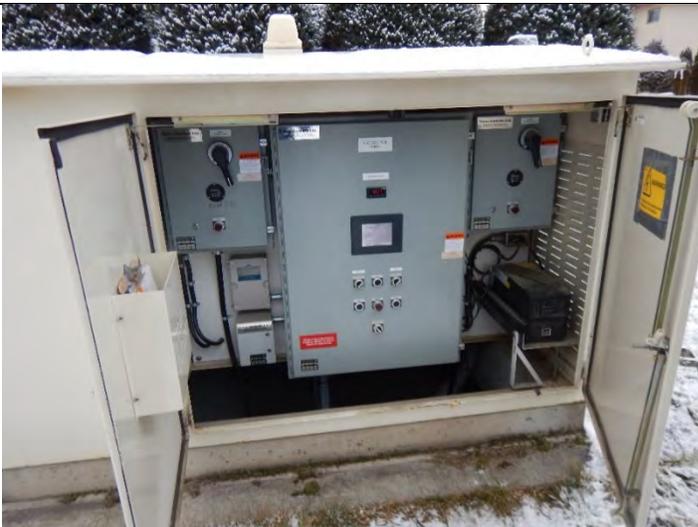
Photo of controls at Ash Street Lift Station.

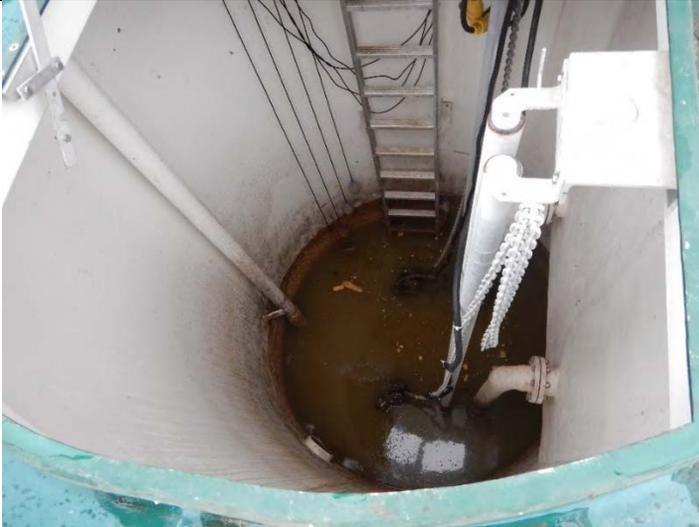
Canoe View Lift Station

Photo shows the inside of the wetwell

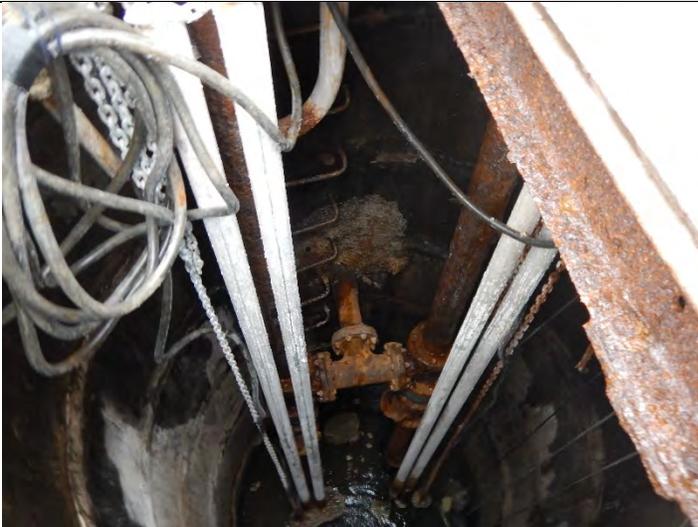
Photo shows the internal piping and valves.

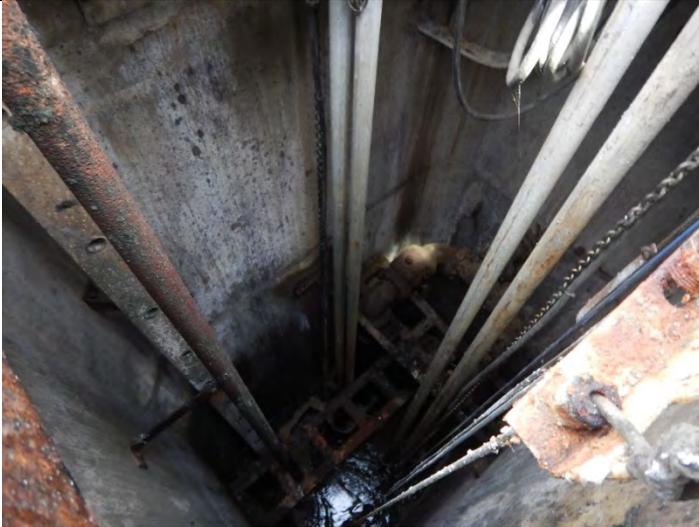
Dogwood Lift Station

Photo of wetwell and internal piping at Dogwood Lift Station.

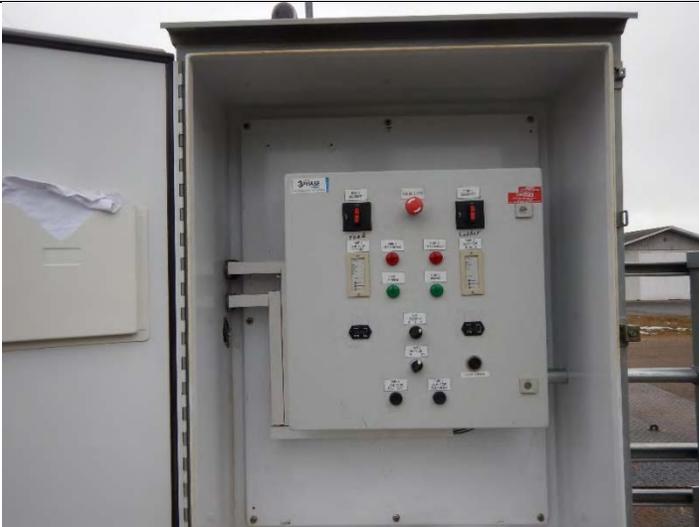
Photo of Controls at Dogwood Lift Station

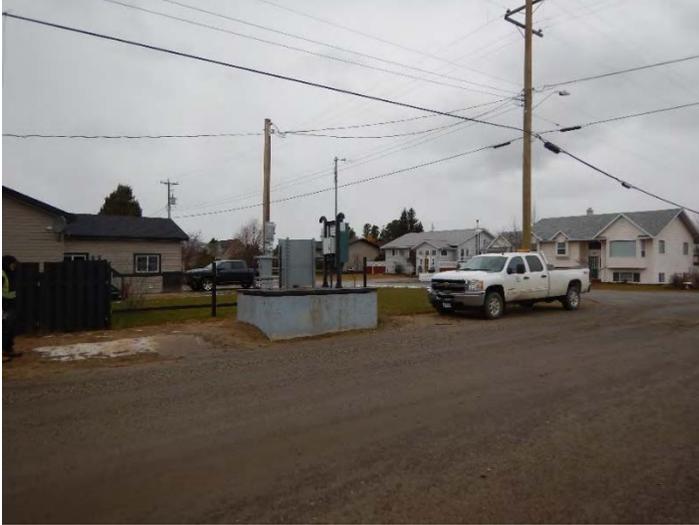
Photo of general site arrangement
at Dogwood Lift Station.

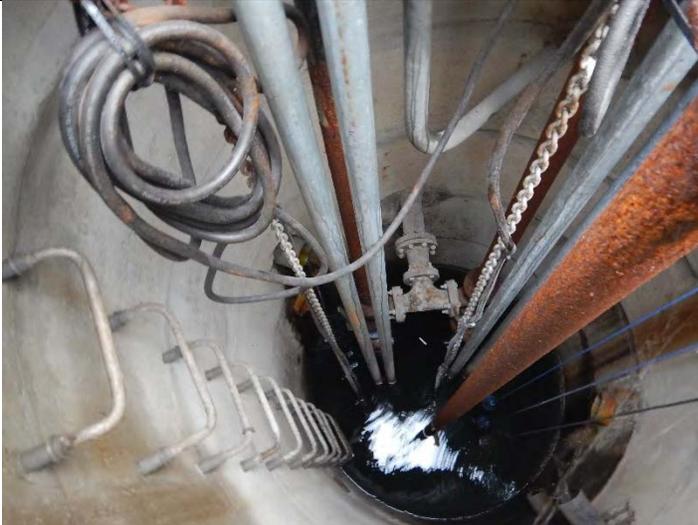
Photo showing wetwell and valves and internal piping at Elm Street Lift Station

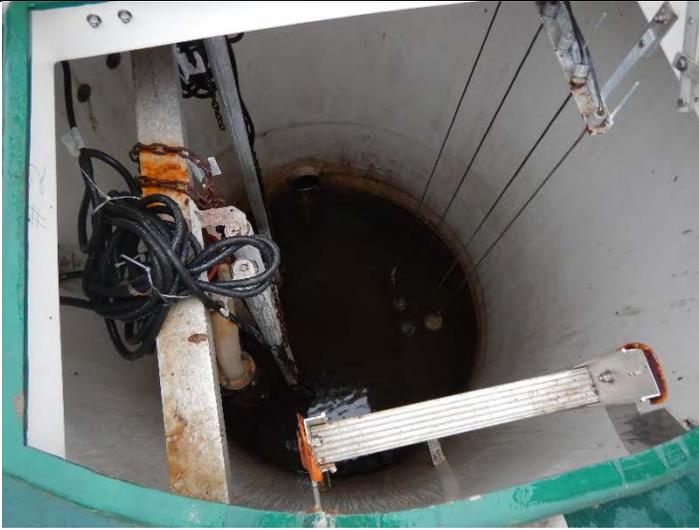
Photo of inside wetwell for Village Office Lift Station.

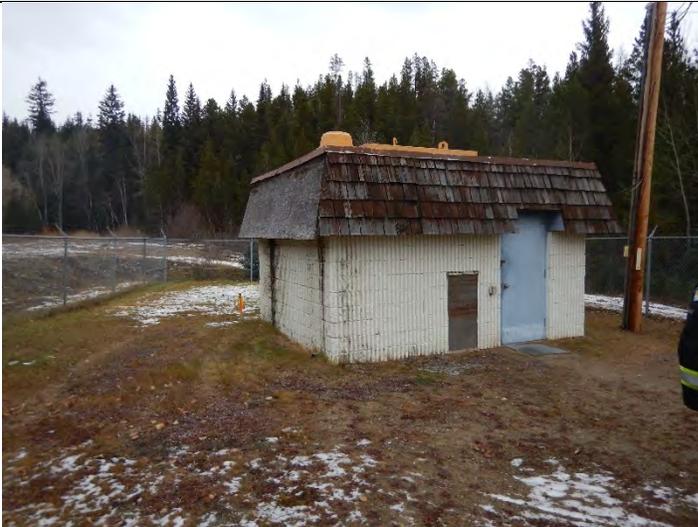
High lift pump station building

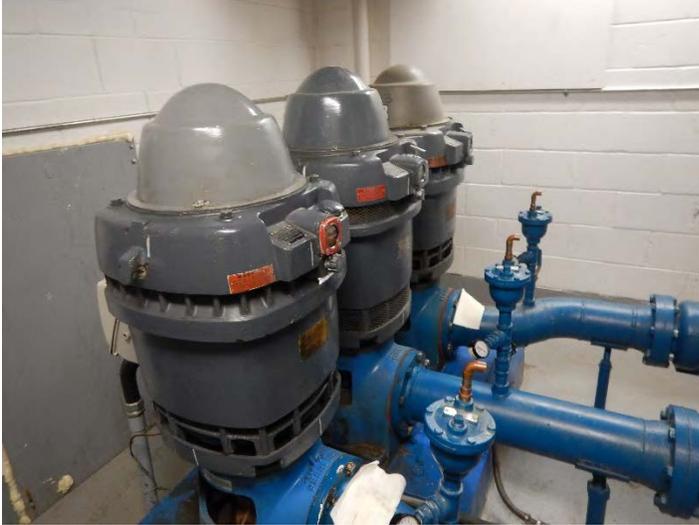
High lift pump station – pumps 1, 2, and 3

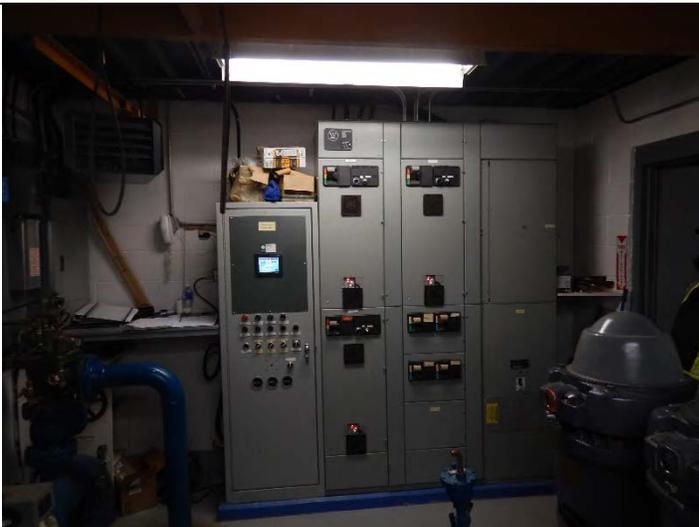
High lift pump station – controls panel
