IMPROVING ASSET MANAGEMENT PLANNING AT THE VILLAGE OF VALEMOUNT

SUMMARY OF FINDINGS & RECOMMENDATIONS

FINAL REPORT – MARCH 2020

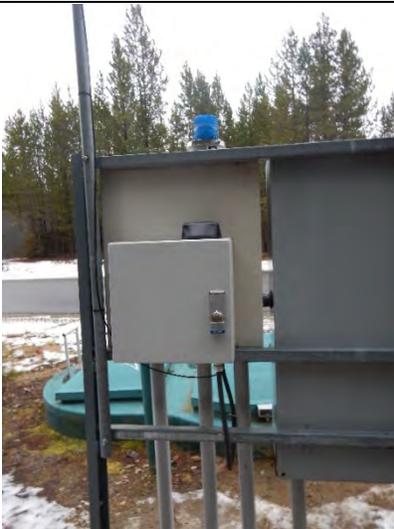
Photo of auto dialer at Canoe View Lift Station

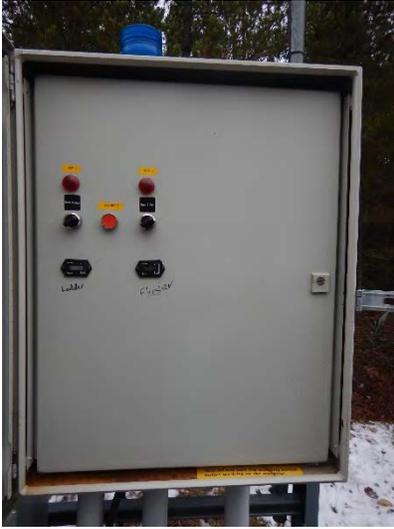
Photo of Controls Kiosk at Canoe View Lift Station.

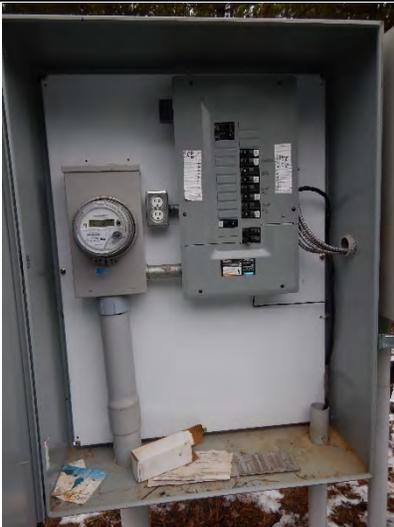
Photo of Electrical Service at Canoe View Lift Station

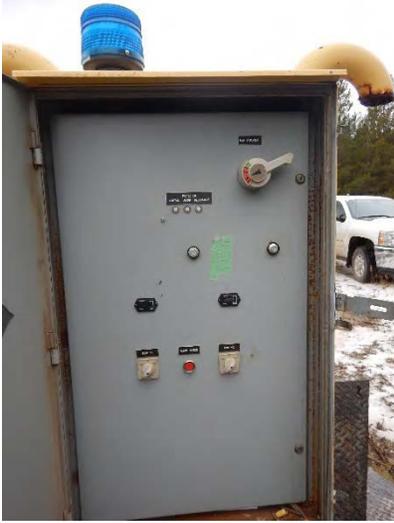
Photo of Controls at 17th Ave Lift Station

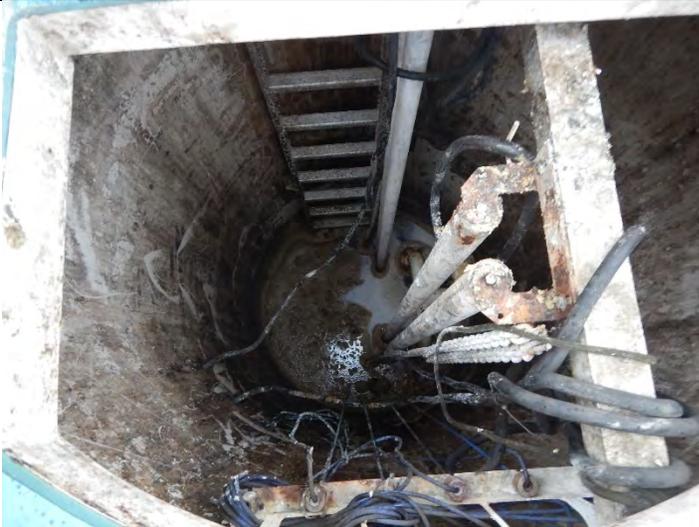
Photo of internal wetwell at Cranberry Place Lift Station.

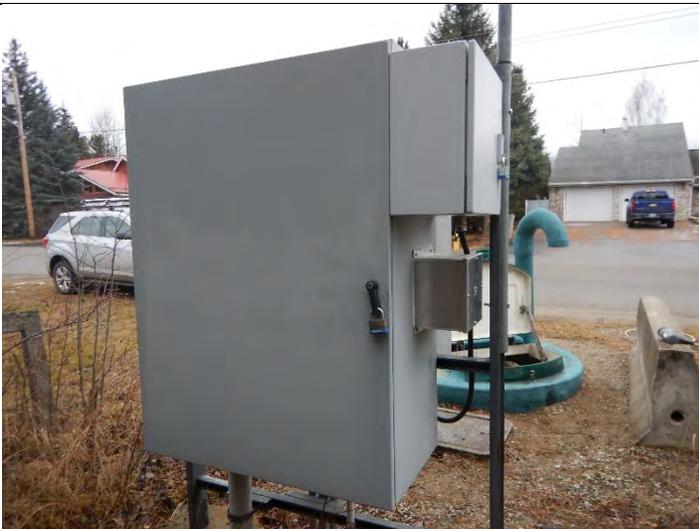
Photo of Control Kiosk at Cranberry Place Lift Station

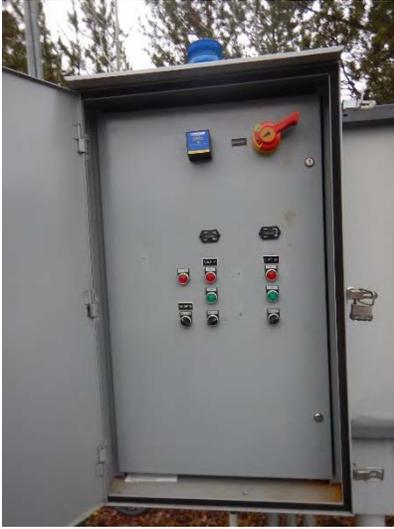
Photo of Control Kiosk at
Cranberry Place Lift Station

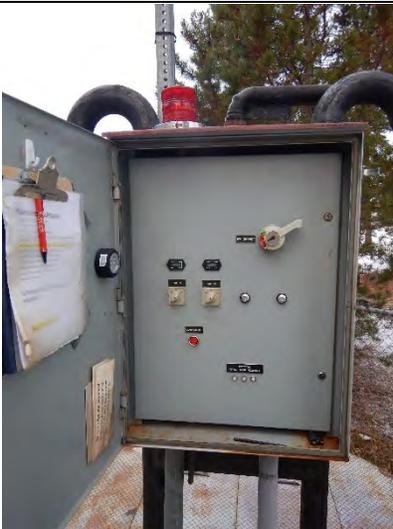
Controls at Elm Street Lift Station

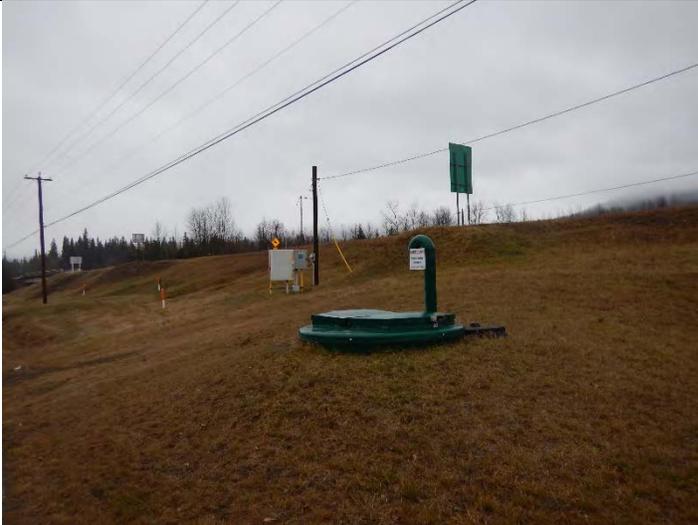
Site layout photo for Village Office Lift Station

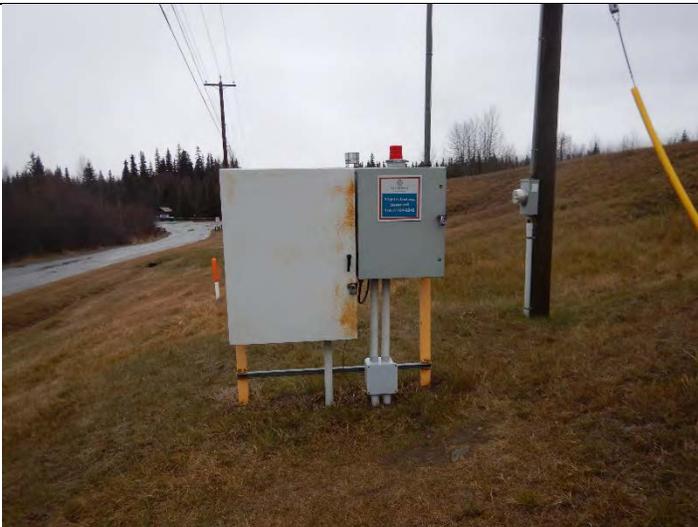
Electrical Controls kiosk.

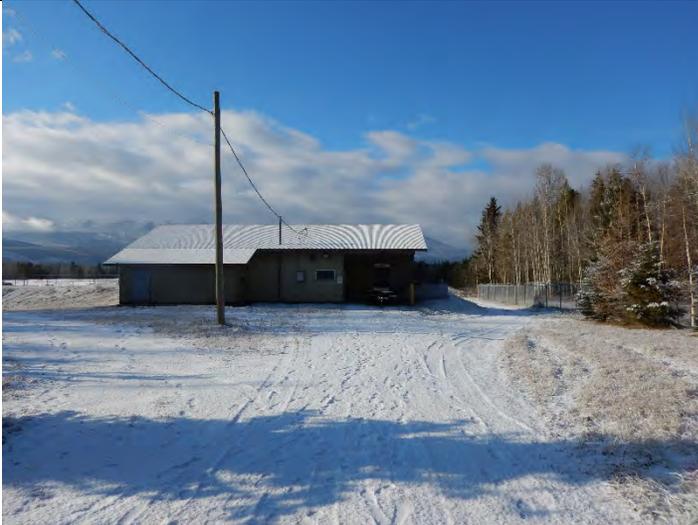
WWTP Building

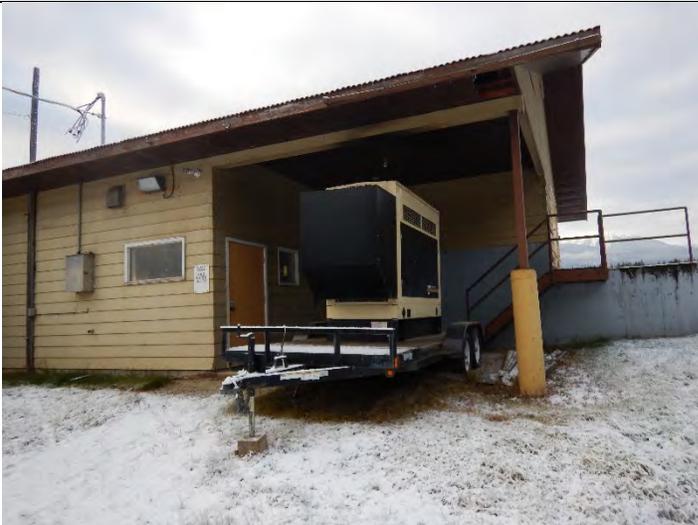
WWTP Building, also shows portable generator on trailer.

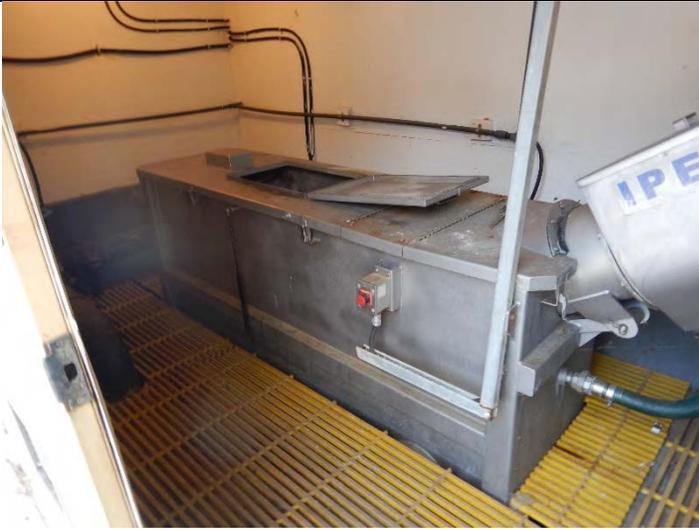
Screening equipment

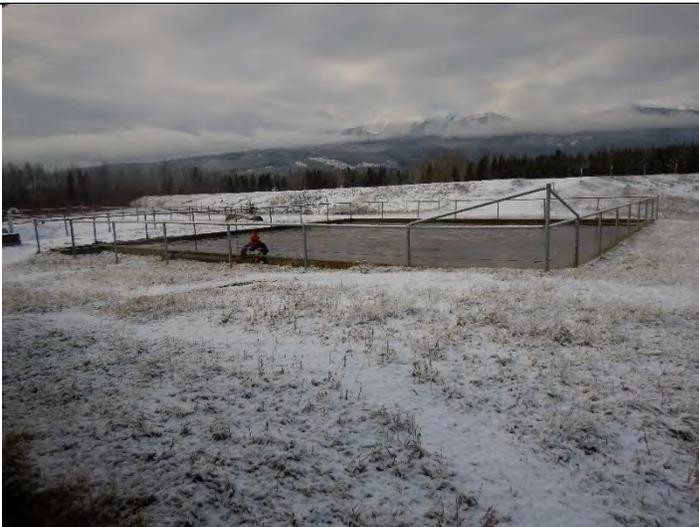
Concrete Aeration Tank.

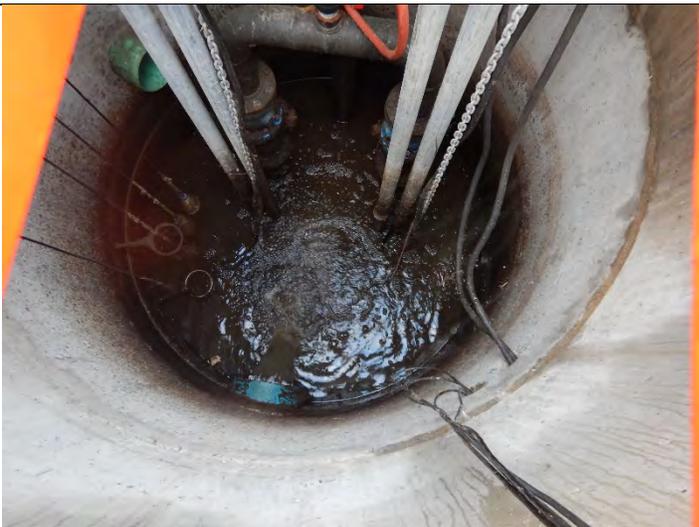
Inside of wetwell for High Lift Station

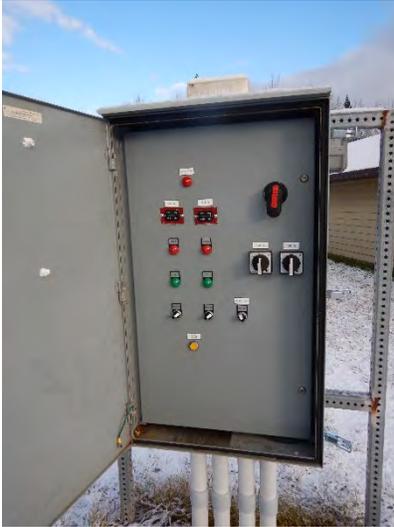
High Lift Station – Controls kiosk

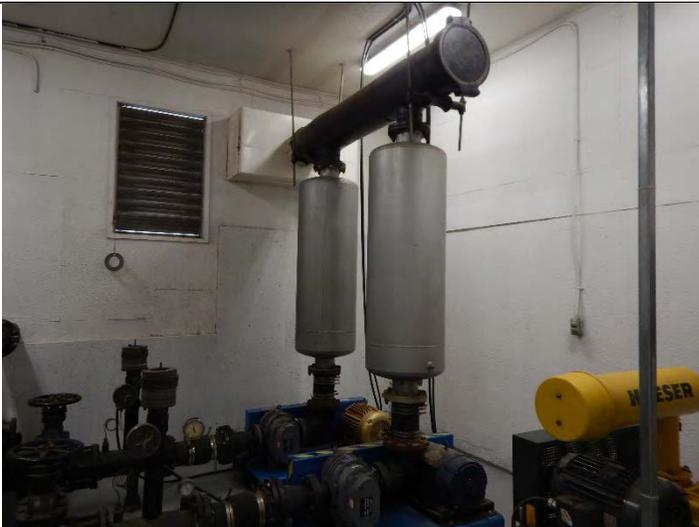
Blowers 1 2 and 3

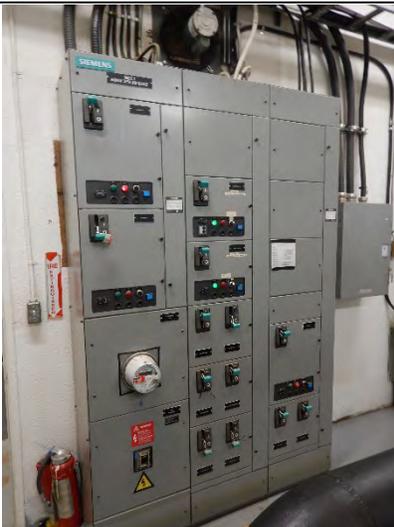
Controls Panel at WWTP

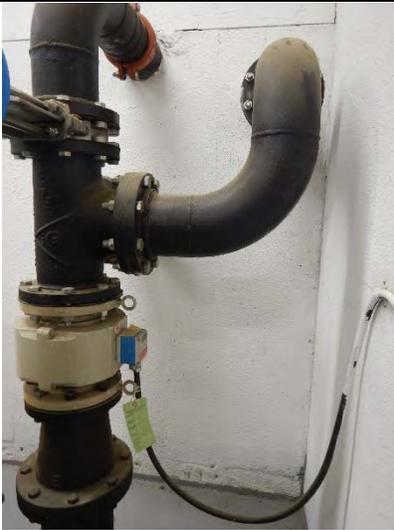
Photo shows the configuration of the flow meter piping

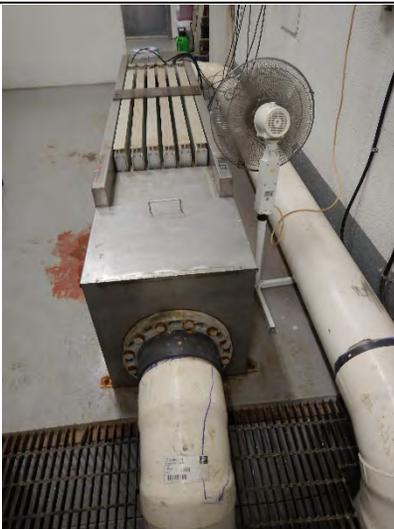
Photo shows the UV Disinfection unit

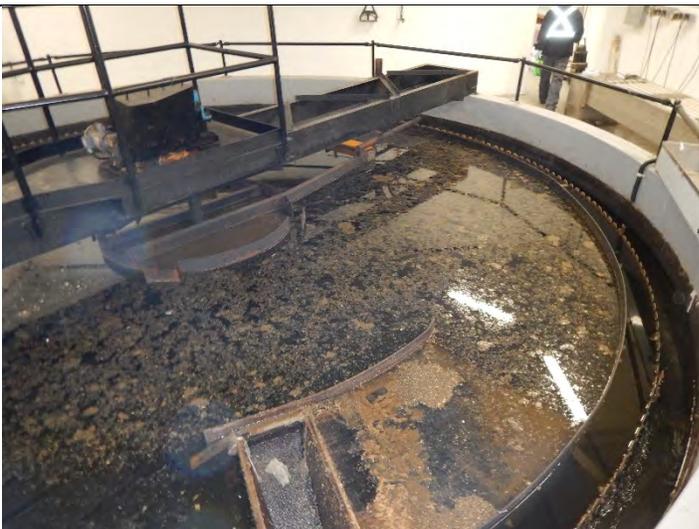
Secondary Clarifier

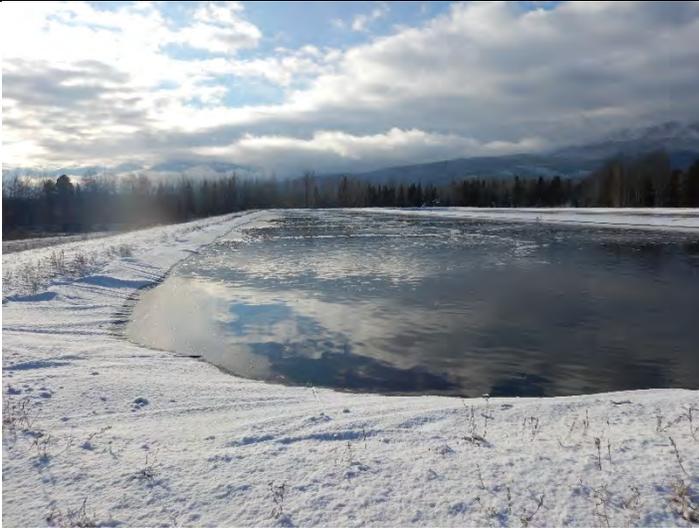
Aerated Lagoon 1

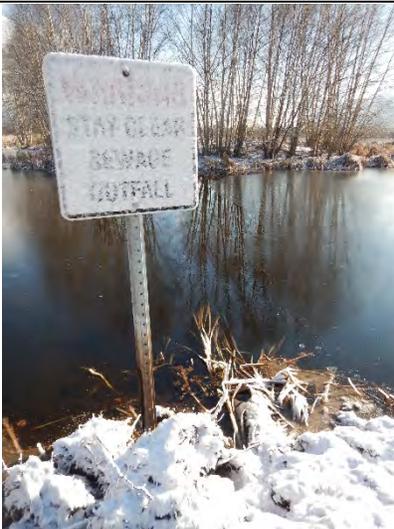
Location of sewage outfall
location to wetlands.

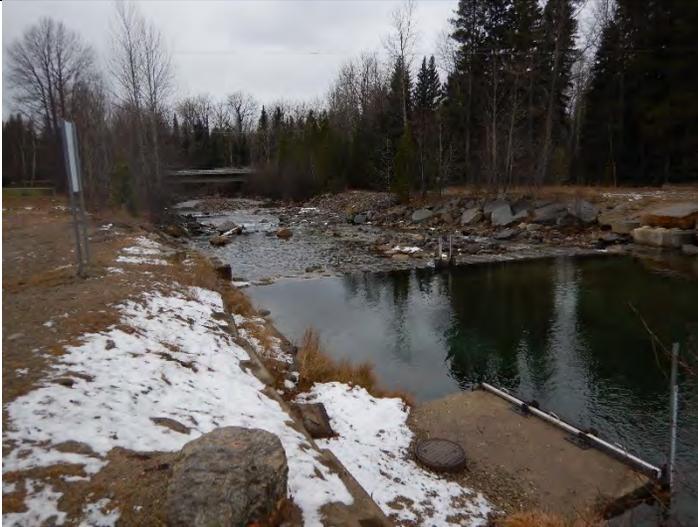
Water system intake structure

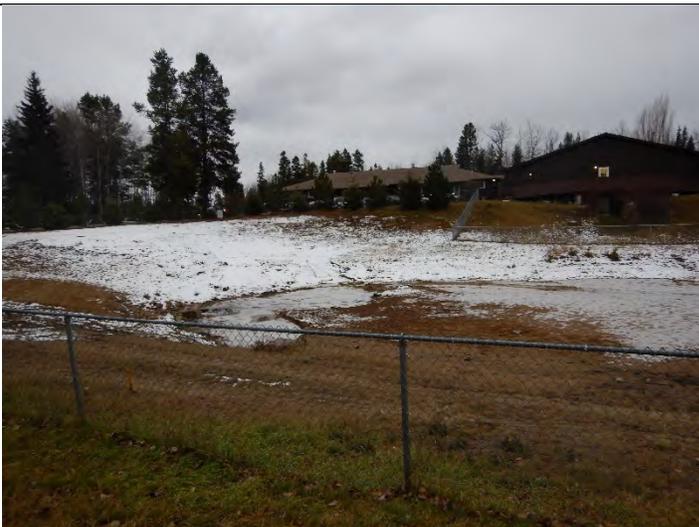
Drainage/overflow pond next to high lift station

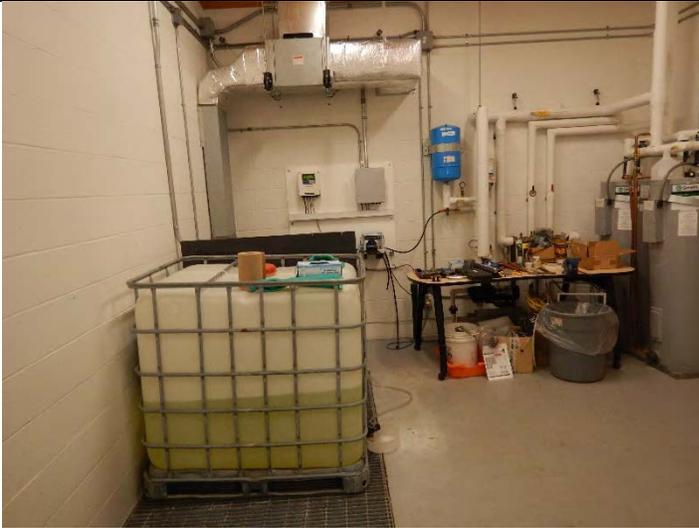
Chlorine storage tank

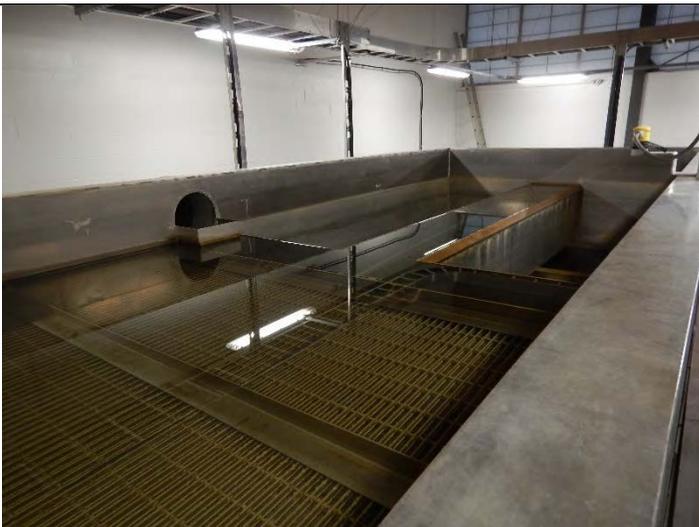
Building water tanks

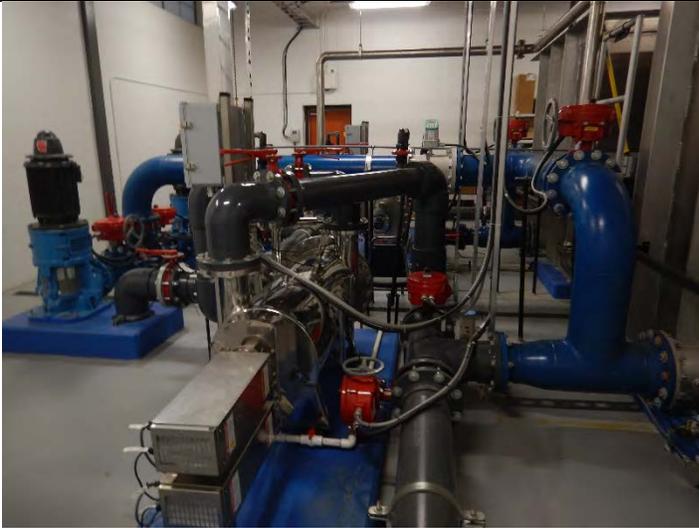
Internal piping and pumps at water treatment plant

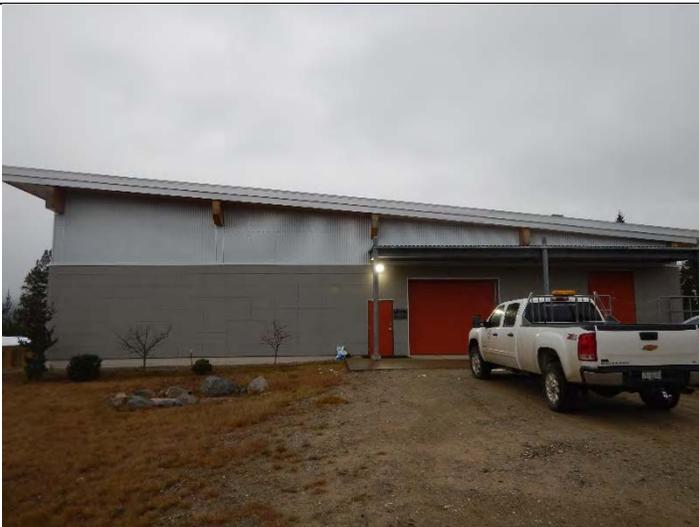
Outside view of building for water treatment plant and Reservoir No. 2

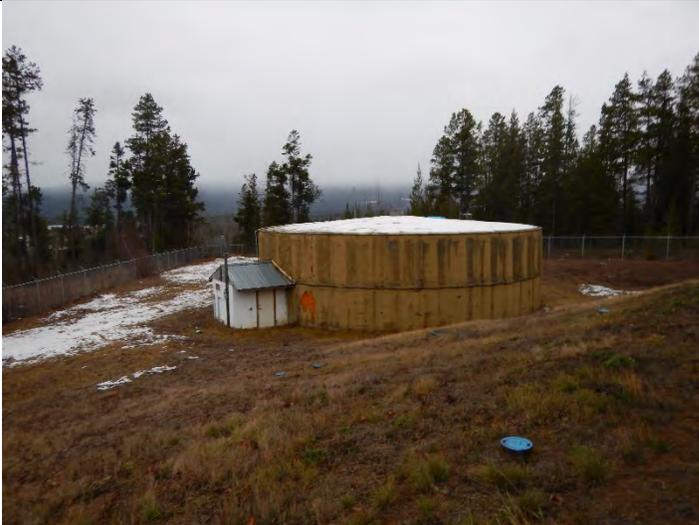
Water Reservoir 1

Photo of Water Reservoir No. 1

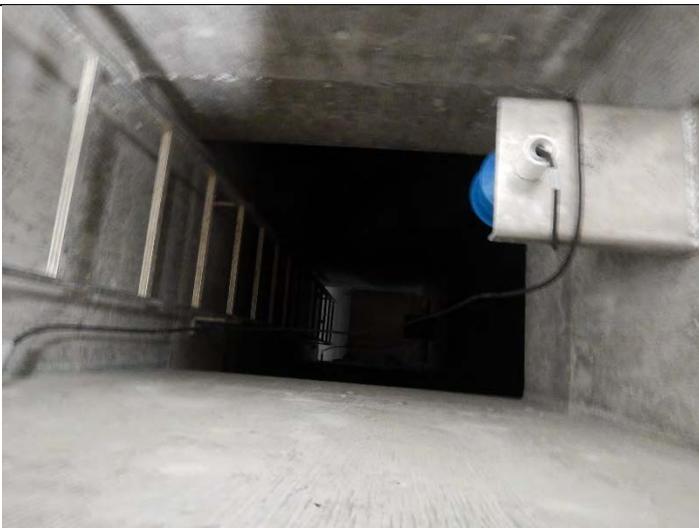
Water Reservoir 2

Look from WTP down into the reservoir #2 access.

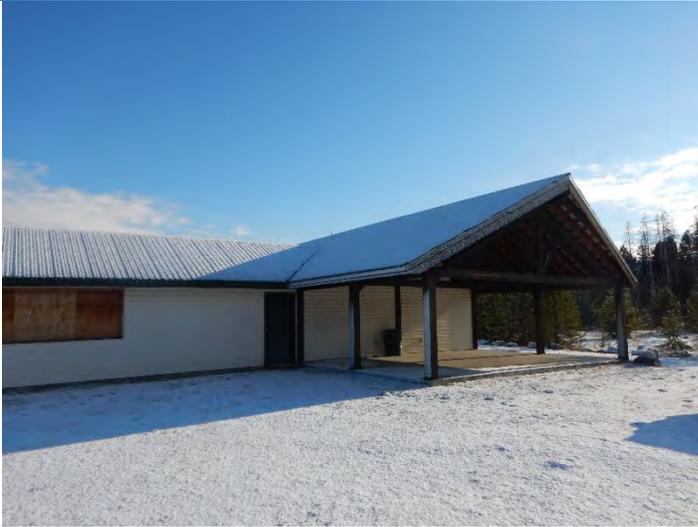
Photo of concession building at park

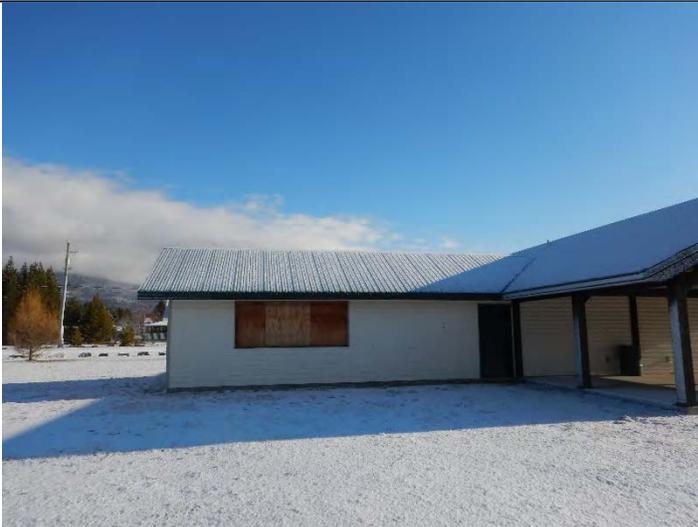
Photo of concession building at park

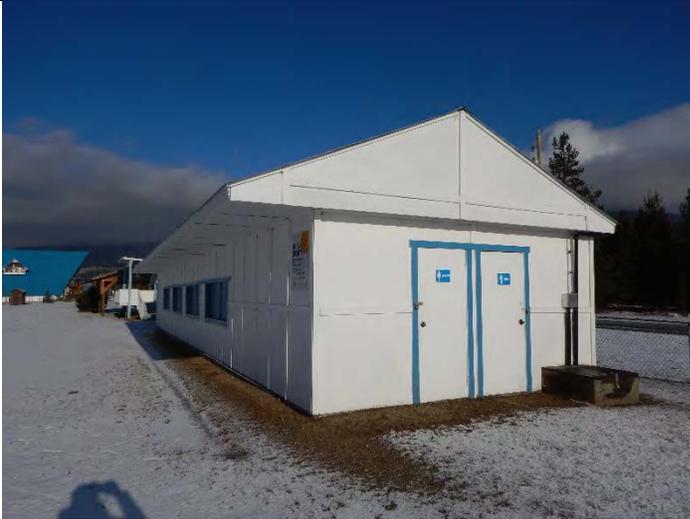
Photo of concession building and washrooms.

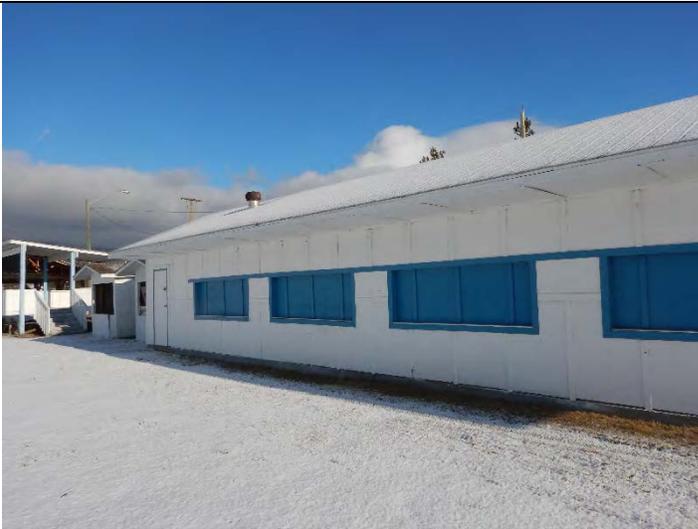
Photo of concession building windows.

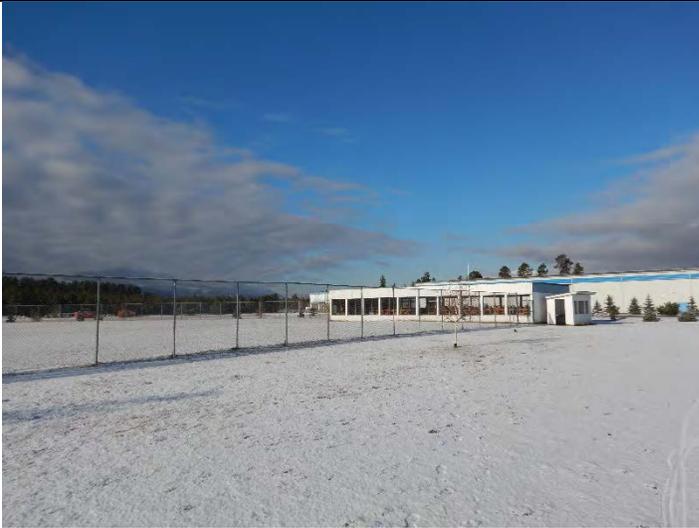
Photo of second building at park.

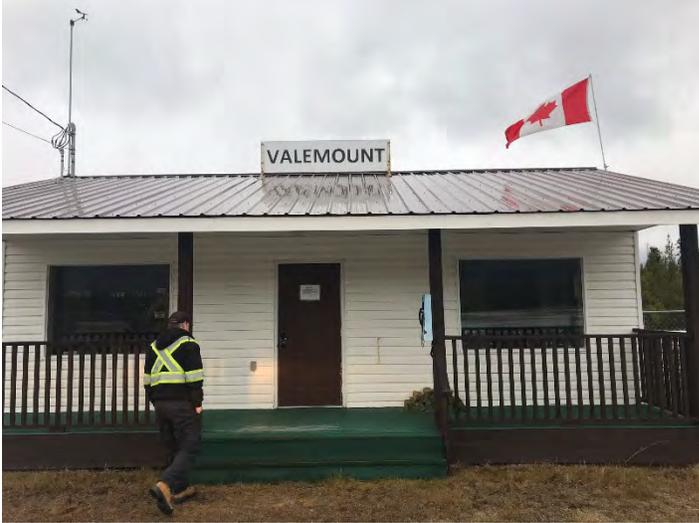
Photo of airport building

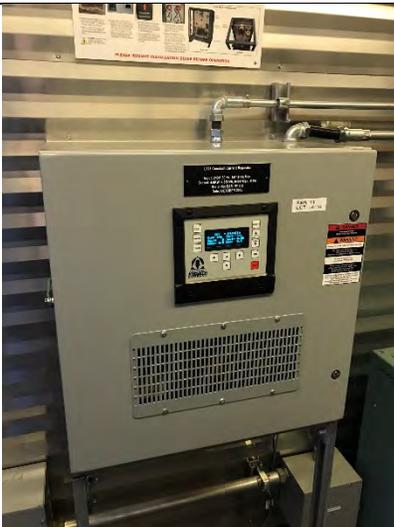
PAPI lighting controls

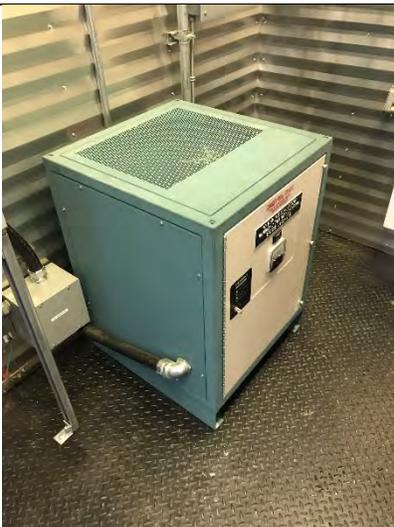
Runway/taxiway/apron edge light regulator
